NASA
Technical Memorandum 107228

Evaluation of a Vibration Diagnostic System for the Detection of Spiral Bevel Gear Pitting Failures

Dennis P. Townsend and James J. Zakrajsek
Lewis Research Center
Cleveland, Ohio

Prepared for the
Seventh International Power Transmission and Gearing Conference
sponsored by the American Society of Mechanical Engineers
San Diego, California, October 6-9, 1996

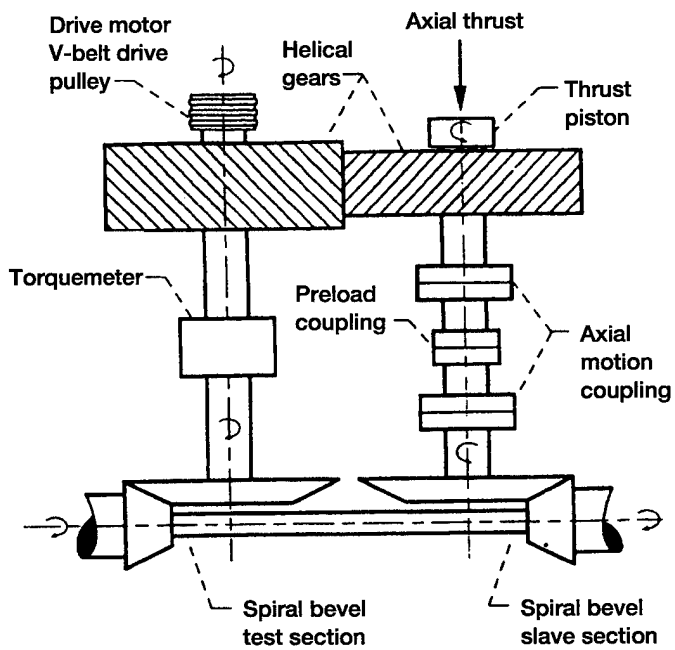
Figure 1.—Crosssection view of test facility.

The spiral bevel gear test rig used for the testing conducted herein is one of two such facilities at NASA Lewis Research Center. A sketch of the bevel gear test rig is shown in Fig. 1 and a cross-section of the test rig showing the main features is shown in Fig. 2. The bevel gear test rig is a closed-loop, torque-regenerative system with a closed loop capacity of 560 kW (750 hp). Power for the rig is provided by a 75 kW (100 hp) variable speed drive motor. The torque is controlled in the closed loop by moving a helical gear with a hydraulically actuated thrust piston. A torque

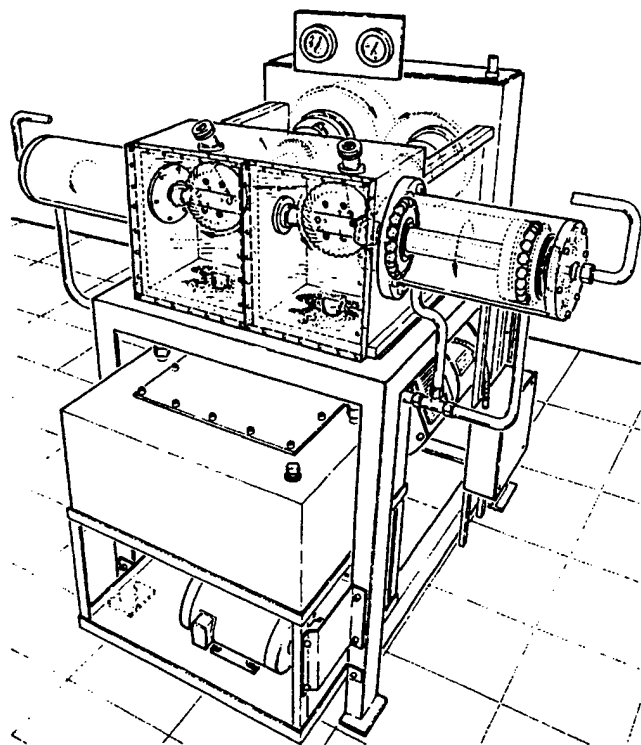
Figure 2.—Sketch of spiral bevel test facility.

As shown in Fig. 2 two sets of spiral bevel gears are tested simultaneously. The slave (right) side operates in a speed increaser mode, where the gear drives the pinion. The test (left) side operates in the intended fashion as a speed reducer. The gear ratio for the test rig is three to one with 12 teeth on the pinion and 36 teeth on the gear. A photograph of the test gears is shown in Fig. 3. The test hardware basic design parameters are given in Table I.

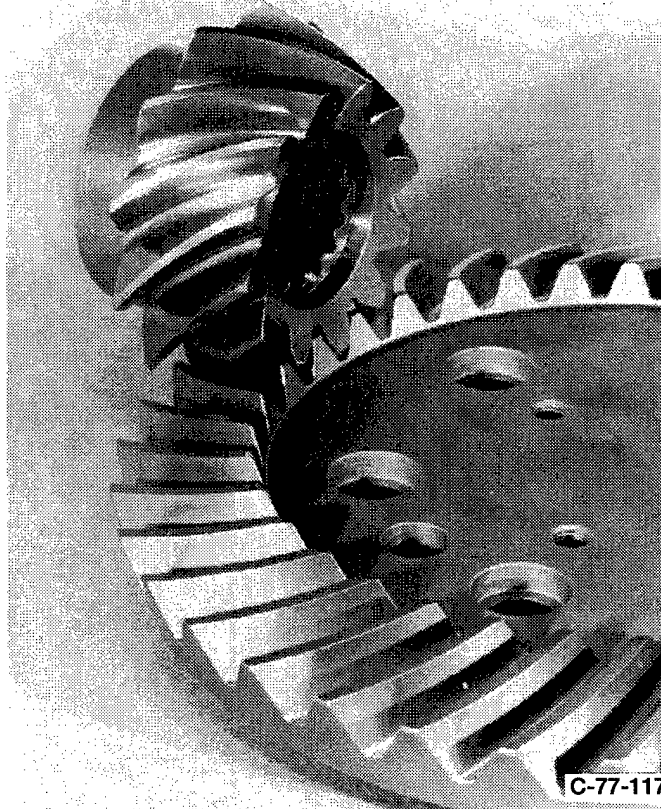
Figure 3.—Spiral bevel test gears.

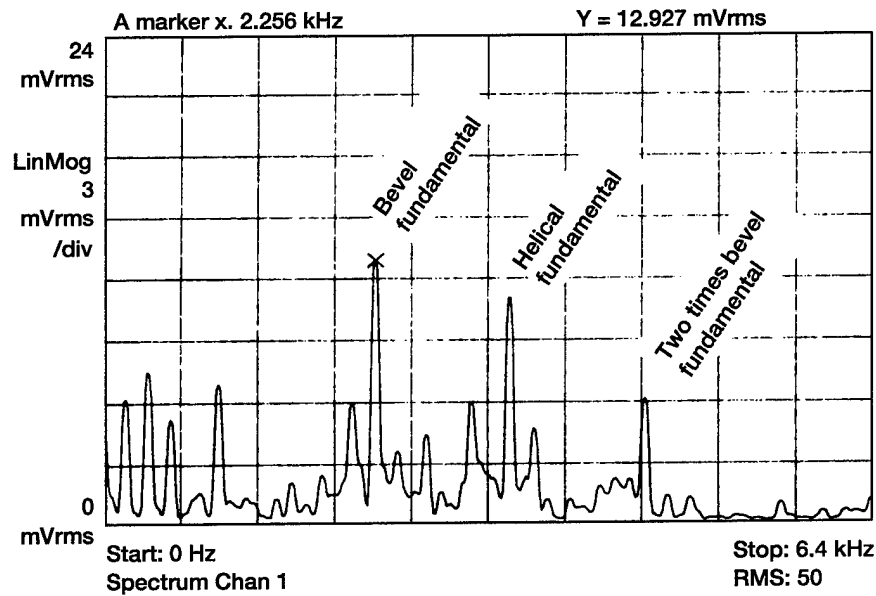
Figure 4.—Typical vibration spectrum from NASA Bevel Gear Rig Pinion speed 11 400 rpm, gear speed 3800 rpm, torque on gear shaft 938 N m (8300 lb/in.).

Accelerometer vibration measurements were taken on the bevel gearbox to find the best vibration accelerometer location, because vibration modes of the gearbox case can affect the gear vibration signal. The best location was found to be on the pinion bearing housing adjacent to the test gear. Figure 4 is a spectrum of the test gearbox showing the various vibration frequencies. The once per revolution of the pinion and the first and second harmonic of gear mesh frequency are clearly seen. The peak at approximately 1.5 times the pinion mesh frequency is the mesh frequency of the helical gears which have 55 teeth each.

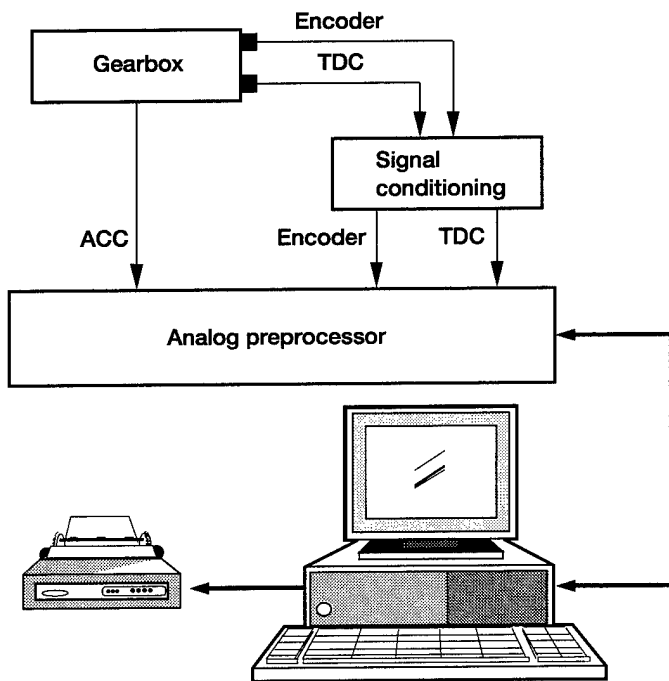
Figure 5.—Gear diagnostic system.

The diagnostic system used in this research program is a commercial gear diagnostic system. The system consists of a personal computer with an analog to digital board installed, a signal conditioning system, and a software package. A schematic of the system is shown in Fig. 5. The signal conditioning system includes a computer controlled tracking filter, computer controlled analog signal conditioning, a pulse rate multiplier/divider, and interfacing electronics. The software automatically sets and monitors the analog signal conditioning circuitry, performs the analysis and provides monitor displays of individual gear tooth vibration images. Gear condition status and alarms are issued when appropriate. The software can display current and past data in a variety of different formats. A flow chart of the system is shown in Fig. 6.

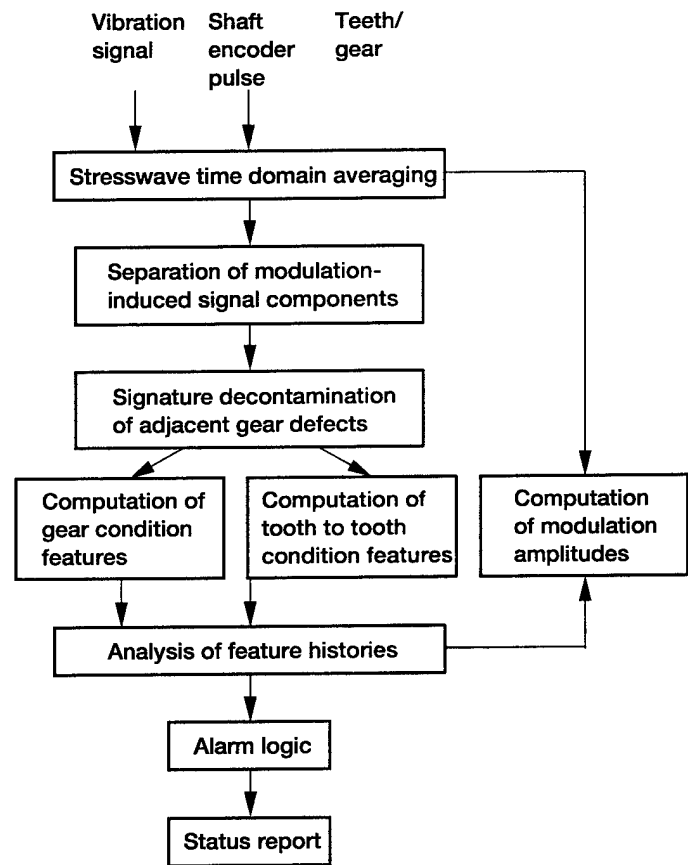
Figure 6.—Gear diagnostic system flow chart.

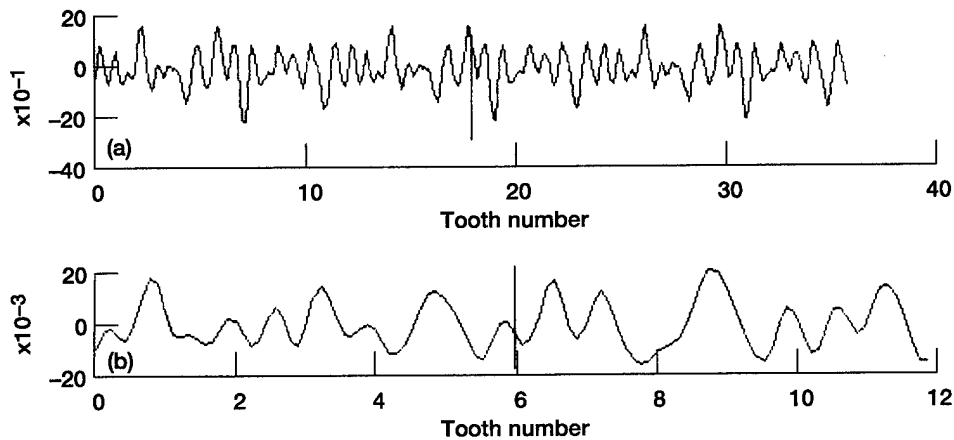
Figure 7.—Typical time synchronous average plots for spiral bevel test rig. Pinion speed 11 400 rpm, gear torque 938 N m (8300 lb/in.). (a) Gear baseband plot. (b) Pinion stresswave.

amplitude modulation function, or envelope, was then constructed. The envelope of the baseband vibration depicts the vibration pattern of each tooth on the gear, using the low frequency components of the signal. Figure 7 shows examples of gear baseband and pinion stresswave plots. The stresswave plots are generated from a high frequency band. This high frequency band was demodulated about a harmonic of the meshing frequency, then the amplitude modulation function was constructed. The envelope of the high frequency band is also known in this system as the gear stresswave. The stresswave depicts the vibration pattern of each tooth on the gear, using the high frequency components of the vibration signal. In many cases the resolution of the tooth meshing pattern is considerably better in the stresswave, than the baseband envelope. This is due to the decreased effect of the vibration transfer path dynamics at higher frequencies.

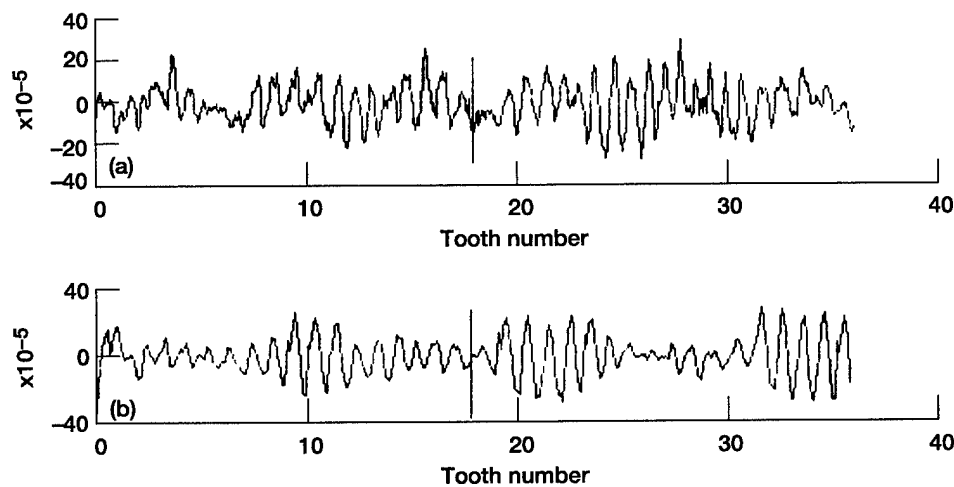
Figure 8.—Time synchronous average plots of gear for test run A. (a) Gear raw baseband plot. (b) Gear baseband envelope.

Figure 8(a) shows a plot of the gear pair raw baseband and Fig. 8(b) shows a plot of the gear pair base band envelope from the test A with the loose pinion hold down nut which ran a total of 122 hr. These plots were taken near the end of the test. The horizontal scale covers one revolution of the gear and shows the condition of each of the 36 teeth on the gear, while the vertical scale is the amplitude of the signal and indicates the intensity of the tooth load. Figure 8(a) shows an increase and decrease in amplitude at three locations during one revolution of the gear which indicates the eccentric condition of the pinion which is running at three times the speed of the gear. The 36 teeth on the gear can be seen in these plots.

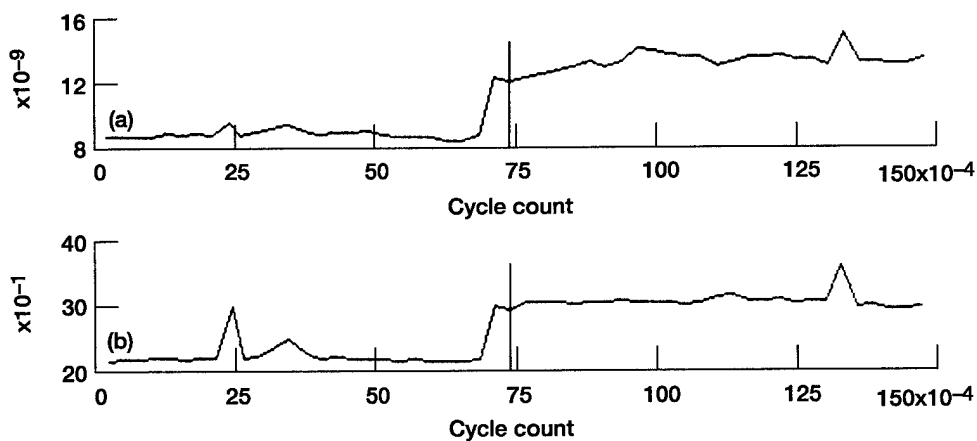
Figure 9.—Features plots of gear for test run A. (a) Total energy gear baseband envelope. (b) Kurtosis of gear baseband envelope.

Figures 9(a) and (b) shows some of the feature plots, produced by the diagnostic system for the test A with the loose nut. These plots show the various parameters from the start until the end of testing and are generated from the data shown in Figs. 8(a) and (b). These plots show the total energy of the gear base band envelope (Fig. 9(a)) and kurtosis of the gear raw baseband (Fig. 9(b)). From these figures it appears that something happened approximately half way through the test, however there were no indications of a failure in the time averaged vibration plots at this time. Near the end of the test these feature plots still indicate that something has happened. The time averaged vibration plots show a three cycle wave giving a change in amplitude with each revolution of the pinion. This condition was caused by a loose pinion nut that allowed the pinion to run in an eccentric condition thereby producing the three cycle amplitude variation per gear revolution.

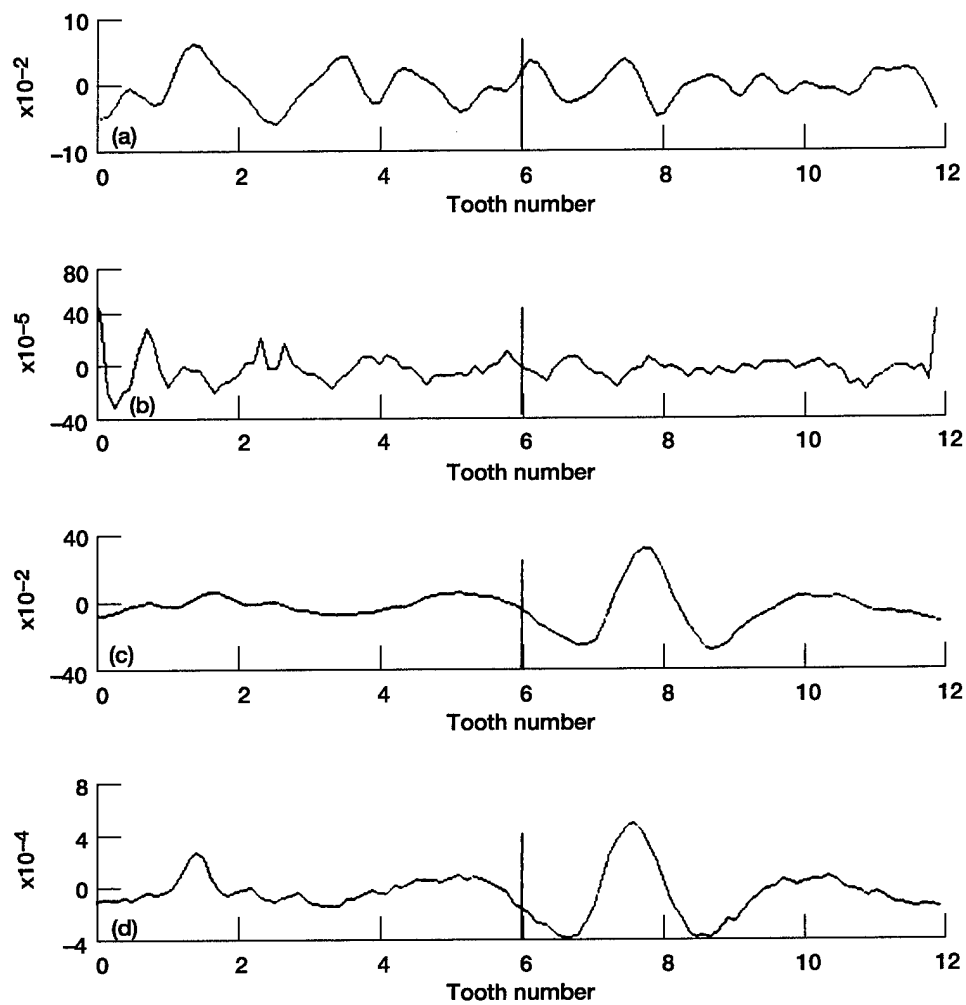
Figure 10.—Time synchronous average plots of pinion for test run B. (a) Pinion stresswave start of test. (b) Pinion baseband envelope start of test. (c) Pinion stresswave end of test. (d) Pinion baseband envelope end of test.

Figures 10(a) to (d) shows the time averaged plots of the pinion stresswave and the pinion base band envelope from test B. Plots 10 a and b were taken at the start of the test and plots 10 c and d were taken at the

end of the test. Near the end of the test the pinion stresswave and pinion baseband envelope show an increased amplitude for one tooth (tooth number 8). This indicates an increased loading for this tooth.

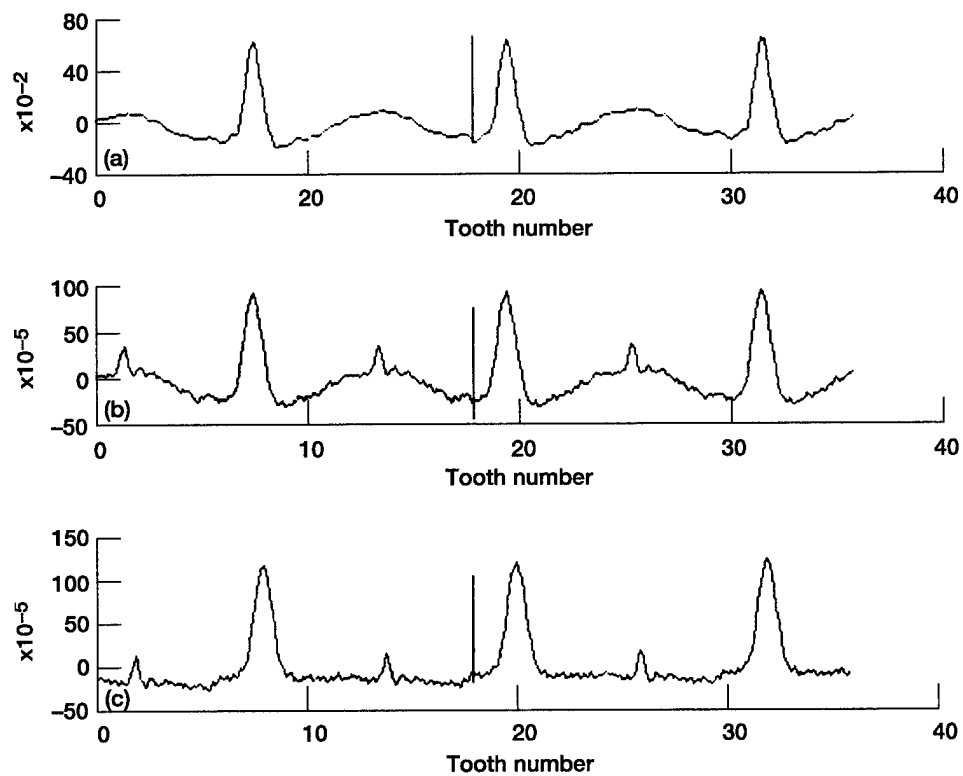
Figure 11.—Time synchronous average plots of gear for test run B. (a) Gear stresswave. (b) Gear baseband envelope. (c) Hunting tooth baseband envelope.

Figures 11 (a) to (c) are the time averaged plots of the gear stresswave, gear baseband envelope, and hunting tooth baseband envelope for test B. Each of these curves shows the gear teeth at locations 8, 20, and 32 to have a very high amplitude compared to the other teeth on the gear. These are exactly 12 teeth apart which is the number of teeth on the pinion. This increased amplitude of the three teeth on the gear is a result of the surface fatigue damage of one tooth on the pinion shown in Fig. 12.

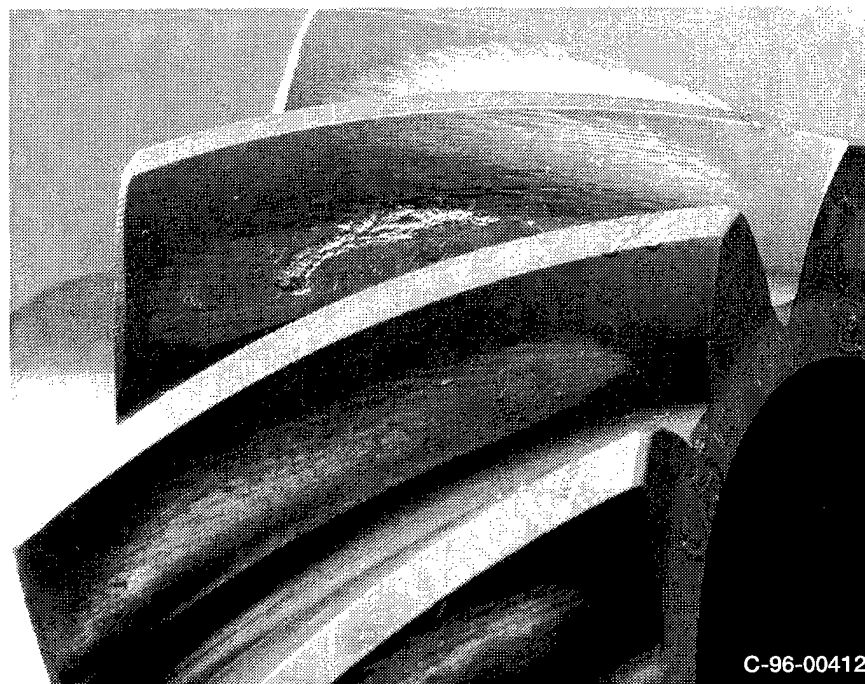
Figure 12.—Pinion tooth fatigue spall test run B.

Figure 13 shows six of the 14 feature plots, for test B. These plots were generated from the data shown in Figs. 10 and 11. Figures 13(a) to (c) are the (a) peak residual ratio, (b) kurtosis and (c) total energy of the pinion stresswave. Figures 13(d) to (f) are (d) the peak residual and (e) total energy of the gear baseband envelope and (f) the kurtosis of the gear stresswave. From these figures it is clear that not much damage occurred until the last 15 percent of total test time. After about 85 percent of total test time all of the above indicators began a steady and continuing increase in amplitude until the test was stopped. The pinion time averaged plots, Figs. 10(c) and (d) show that one tooth (tooth number 8) on the pinion was producing a higher dynamic load than the other teeth. This tooth was found to have fairly sizable fatigue spall as shown in Fig. 12.

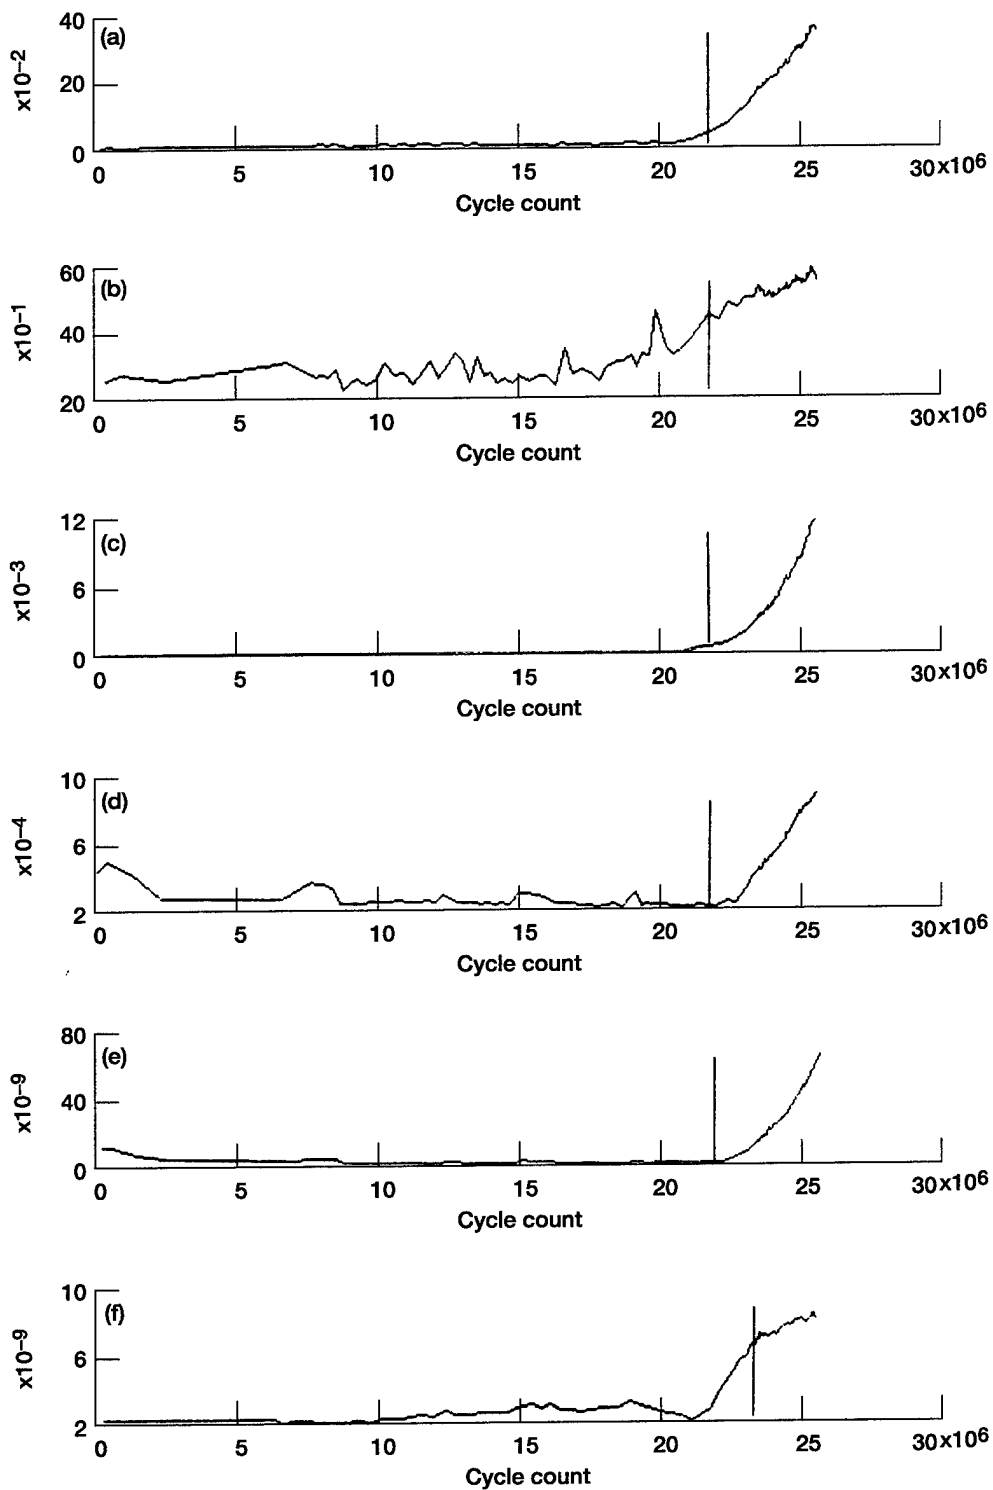
Figure 13.—Features plots for test run B. (a) Peak residual pinion stresswave. (b) Kurtosis pinion stresswave. (c) Total energy pinion stresswave. (d) Peak residual gear baseband stresswave. (e) Total energy gear baseband envelope. (f) Kurtosis gear stresswave.

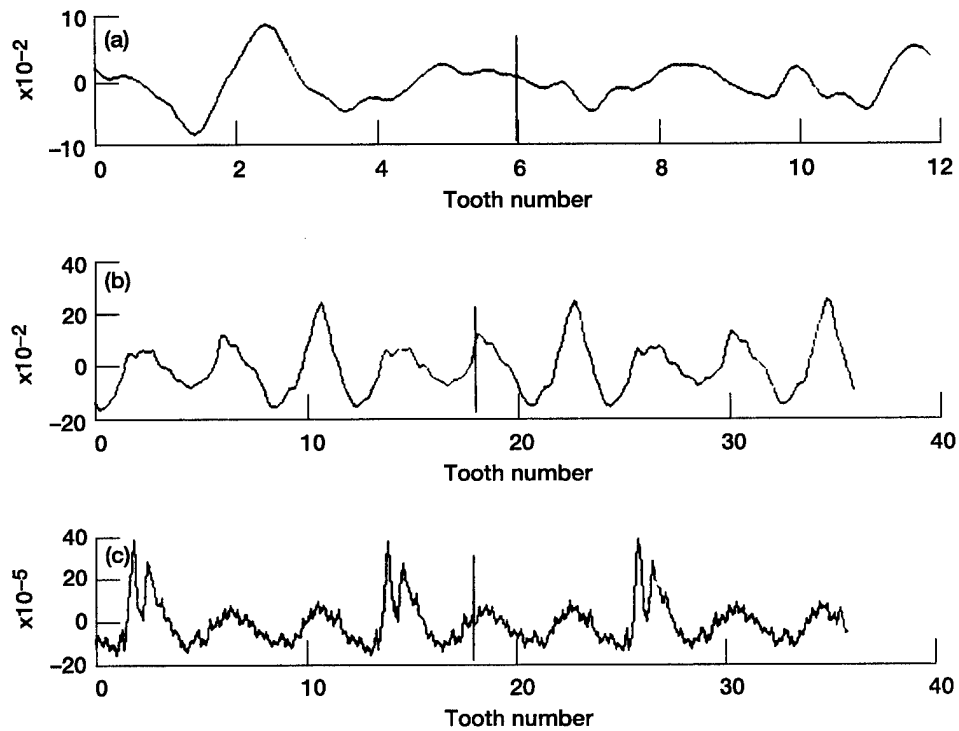
Figure 14.—Time synchronous average plots of test run C. (a) Pinion stresswave. (b) Gear stresswave. (c) Hunting tooth baseband envelope.

Another gear test run C completed a total of 527 hr and had some fatigue damage on one tooth. The plots for the time averaged pinion stresswave, gear stresswave and hunting tooth baseband envelope are shown in Figs. 14(a) to (c) respectively. A signal from each individual tooth cannot be seen on these figures, however these figures show an increase in amplitude for one area of the pinion near tooth number 3 and for three areas of the gear. This indicates that one location on the pinion is contributing to an increase in dynamic load. Figure 15 shows the fatigue spalls on the pinion and gear for test C.

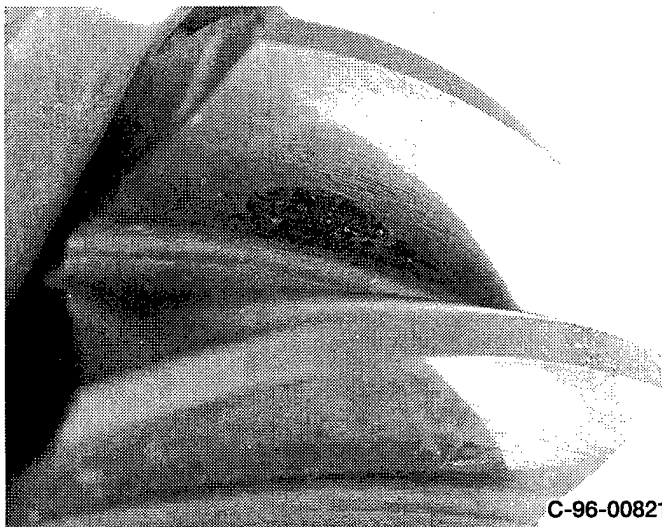
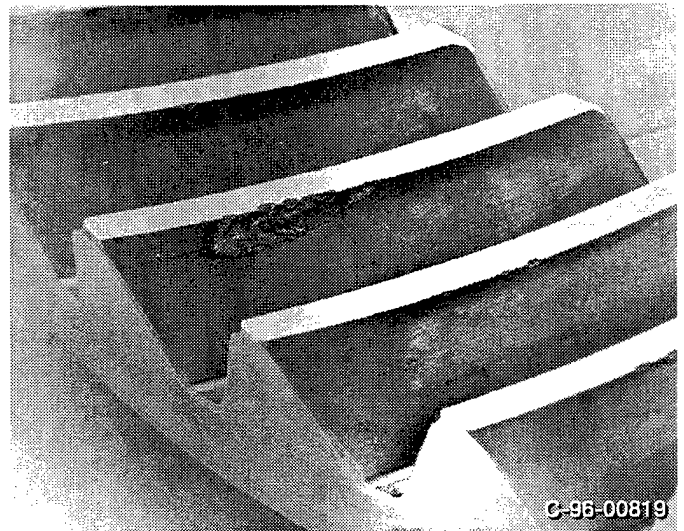
Figure 15.—Gear and pinion fatigue spall for test run C.

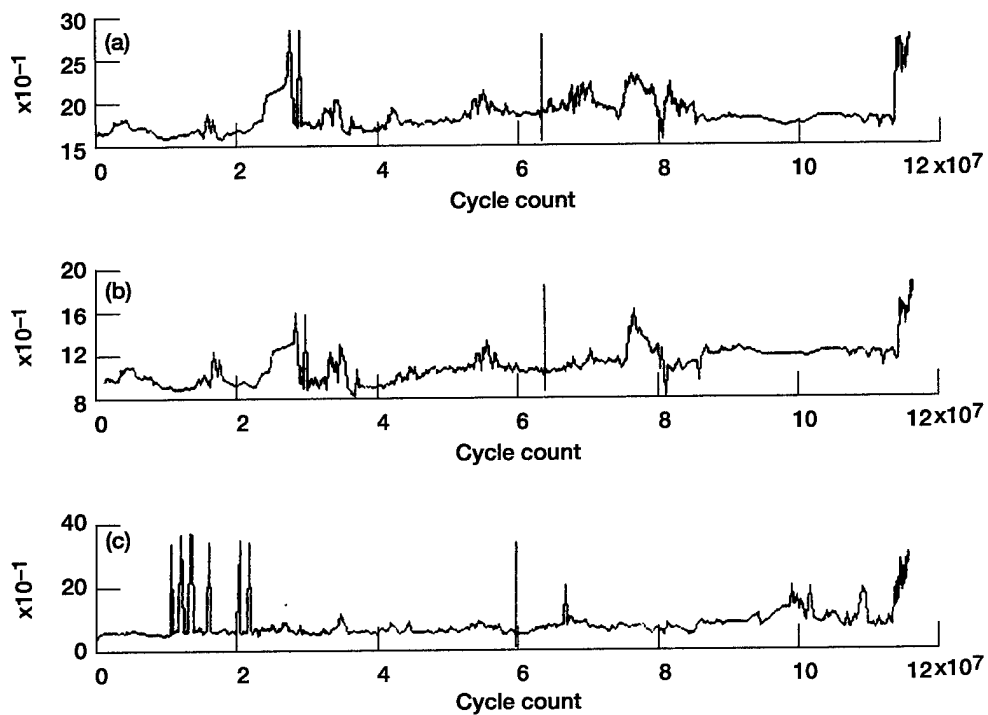
Figure 16.—Features plots of test run C. (a) Kurtosis gear stresswave. (b) Peak ratio gear stresswave. (c) Peak residual ratio baseband envelope.

Figures 16(a) to (c) are the feature plots for test C and show the kurtosis and peak ratio for the gear stresswave and the peak residual ratio for the gear base band envelope. These plots show an increase in these parameters near the end of the test C and are an indication of increased vibration activity caused by the pinion fatigue spall. The earlier peaks were probably the result of stopping and starting the test.
